No. SHAEC1600045602

Hangzhou Freqcontrol Electronic Technology Ltd

The following sample(s) was/were submitted and identified on behalf of the clients as : synthetic quartz crystal blank

Halogen Testing (oxygen bomb) Flow Chart

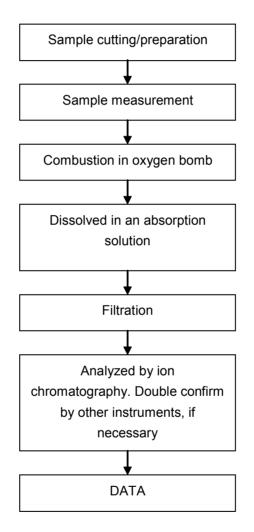
Test Method : With reference to EN 14582: 2007, analysis was performed by Ion Chromatograph (IC).

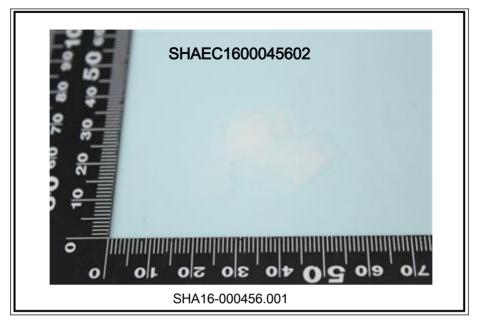
Sample photo:

Specimen No.	SGS Sample ID	Description
SN1	SHA16-000456.001	Translucent solid sheet
